**Flood Control Project Maintenance
Levee Inspections**
LMA District Cover Sheet
Spring 2018 Levee Inspection Results

Madera County FCWCA

**Flood Control Project Maintenance
Levee Inspections
Unit Cover Sheet
Spring 2018 Levee Inspection Results
Madera County FCWCA**

Waterway			Bank	Unit Miles
Unit No. 01 Ash Slough			Right	2.37
	Spring (March - May)	Summer (June - August)	(September - November) Fall	Winter (December - February)
Unit Maintenance Rating (Fall Only)				
Date of Inspection	4/17/2018 - 4/17/2018			
DWR Inspector	Richard Willoughby			
Accompanied By

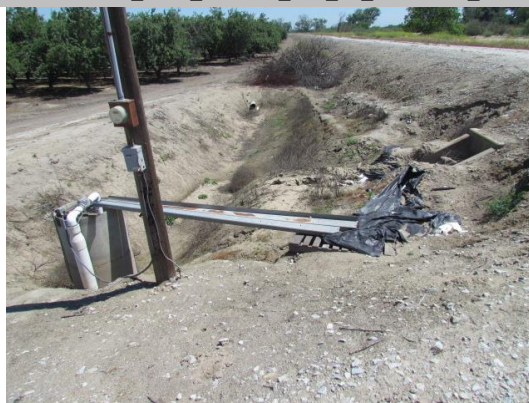
Photo 1 of 1 : SP_2018_NA0011_142_18_20180411_00009.jpg

LM Start	0.03	Rating **	U	Issue No.	18
LM End	0.06	Issue Type +	En	Location *	LS
Category	Earthen Levee			GPS Latitude/Longitude	
				Start	End
Item	Encroachments			37.046566 °	37.046715 °
				-120.427512 °	-120.426964 °
DWR ID	DWR_NA0011_01_s _ 2014_18				
Comment Code					
DT : Ditch					
Inspector Comment					
There seem to be lots of activity going on at this location. This ditch will cause more damage to the levee slope and toe.

Ash Slough looking upstream from the landside slope levee mile 0.03.

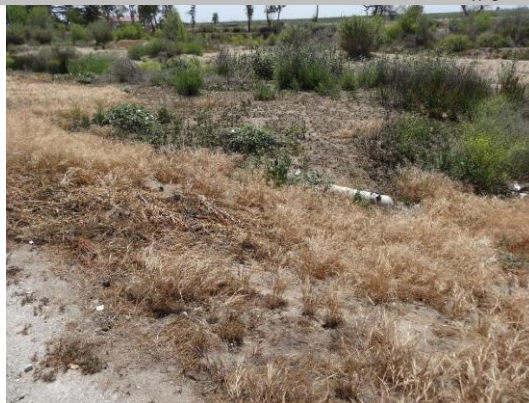
Photo 1 of 3 : UCIP_SP_2018_49976_69674.jpg

View of WS--dense vegetation along WS slope.

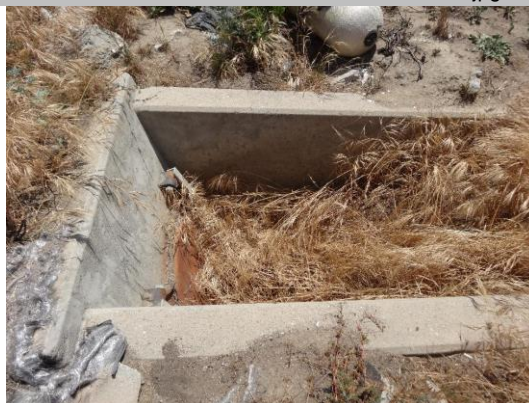
Photo 2 of 3 : UCIP_SP_2018_49976_69673.jpg

Flap gate located on WS blocked by dense vegetation.

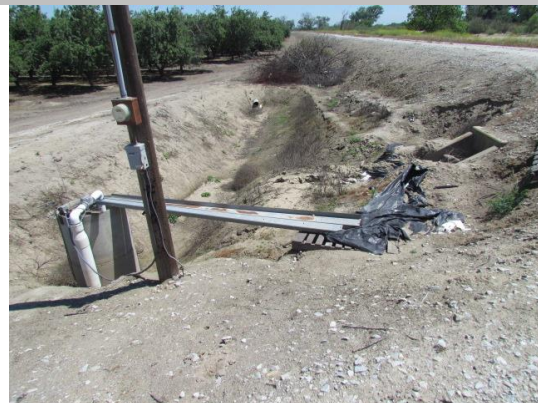
Photo 1 of 1 : SP_2018_NA0011_142_20_20180411_00010.jpg

LM Start	0.04	Rating **	U	Issue No.	20
LM End	0.05	Issue Type +	Ma	Location *	LS
Category	Earthen Levee			GPS Latitude/Longitude	
				Start	End
Item	Slope Stability			37.046624 °	37.046682 °
				-120.427317 °	-120.427108 °
DWR ID	DWR_NA0011_01_s_2014_20				
Comment Code					
S1 : Repair slope instability.					
Inspector Comment					
This is not a new erosion site, it should be repaired before the condition get any worse.

There is damage to the landside levee slope next to the concrete inlet structure.

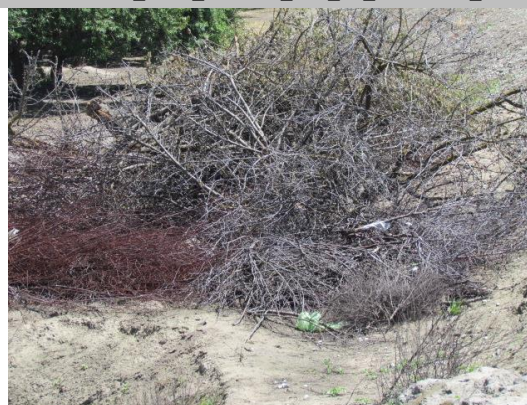
Photo 1 of 1 : SP_2018_NA0011_142_12_20180411_00003.jpg

Unwanted brush pile on the landside levee toe.

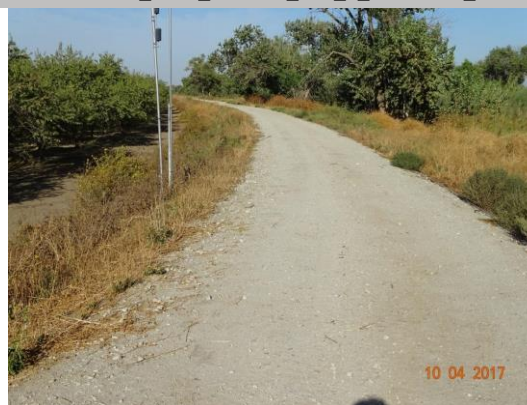
Photo 1 of 1 : SP_2018_NA0011_142_9_20180411_00001.jpg

Tall weeds should be removed from landside slope.

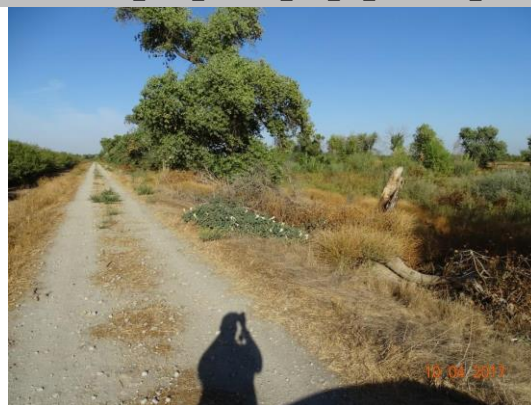
Photo 1 of 1 : SP_2018_NA0011_142_11_20180411_00002.jpg

Remove downed tree from waterside slope.

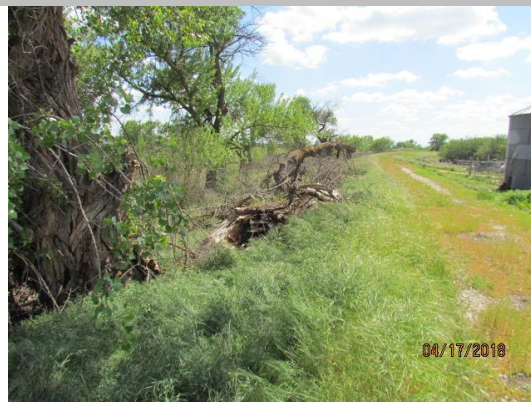
Photo 1 of 1 : SP_2018_NA0011_142_21_20180420_00031.jpg

Looking west at tree limbs and branches on waterward slope. (Spring 2018)

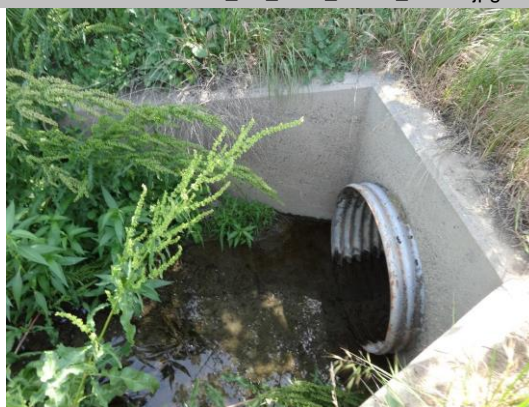
Photo 3 of 3 : UCIP_SP_2018_39686_71660.jpg

Pipe outlet on waterward side.

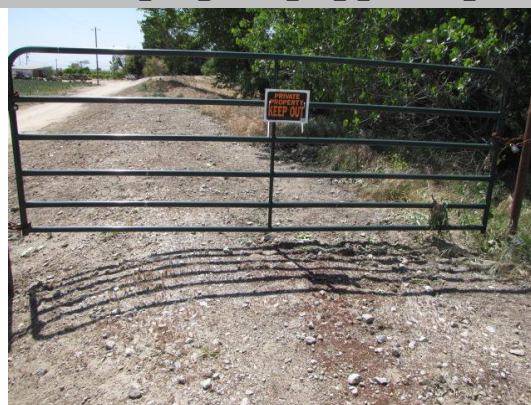
Photo 1 of 2 : SP_2018_NA0011_143_5_20180307_00005.jpg

Unauthorized gate and metal fence placed on slope and toe of levee section. Photo taken 4-17-2013.

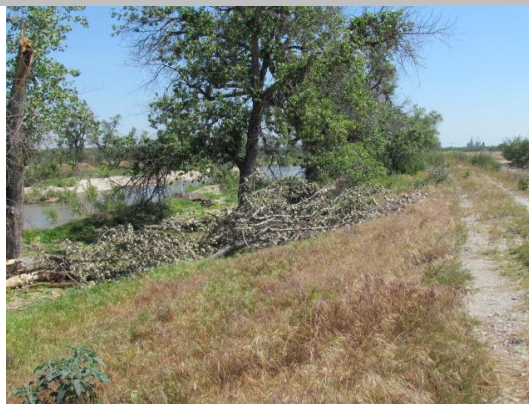
Photo 1 of 1 : SP_2018_NA0011_143_33_20180307_00016.jpg

Dead fallen trees on the waterside levee slope and shoulder.

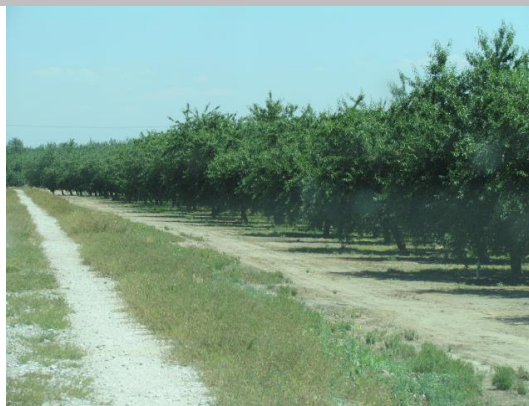
Photo 1 of 1 : SP_2018_NA0011_143_38_20180307_00017.jpg

Looking upstream from levee mile 1.66-2.00 tall weeds present on the landside slope.

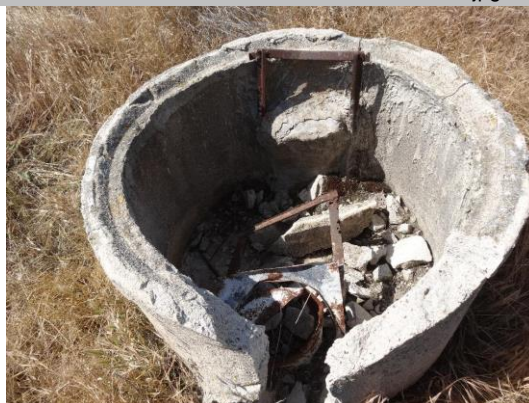
Photo 2 of 3 : UCIP_SP_2018_39925_71820.jpg

36-inch pipe full of concrete debris located on waterward side.

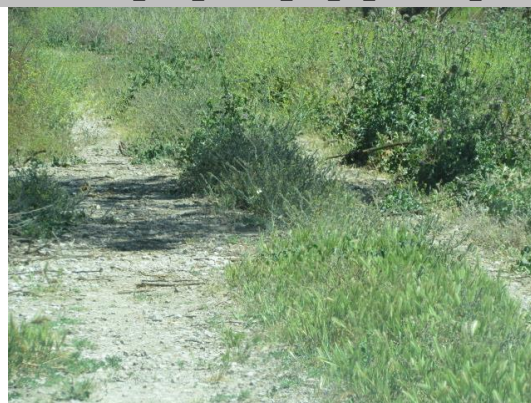
Photo 1 of 1 : SP_2018_NA0011_144_12_20180307_00010.jpg

Looking upstream at the crown roadway that's covered with wild vegetation.

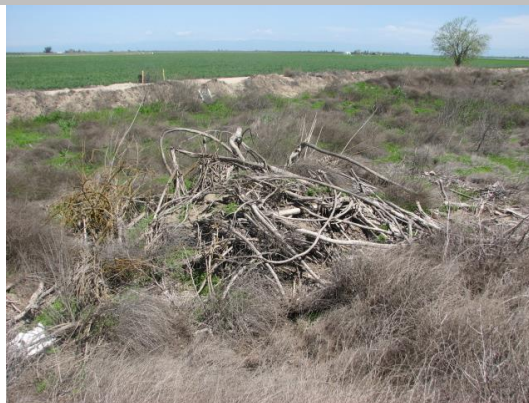
Photo 1 of 1 : SP_2018_NA0011_144_20_20180411_00021.jpg

Looking at prunings on landward slope. (Spring 2018)

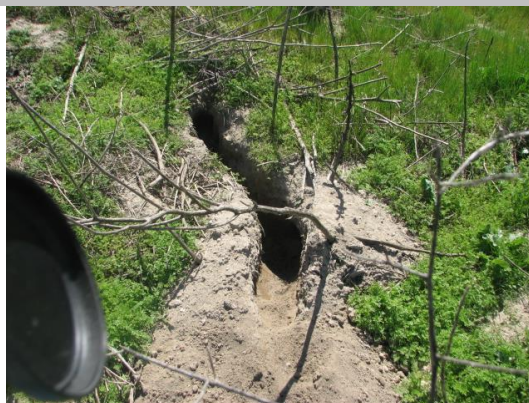
Photo 3 of 6 : SP_2018_NA0011_144_6_20180411_00024.jpg

Looking at rodent hole with erosion on landward slope. (Spring 2018)

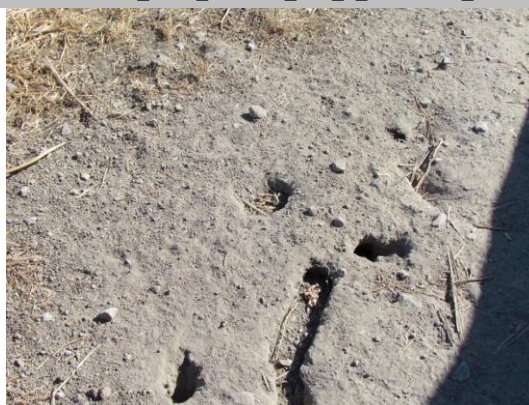
Photo 5 of 6 : SP_2018_NA0011_144_6_20180307_00004.jpg

More active rodents holes and foot traffic seen around holes though no rodents observed.

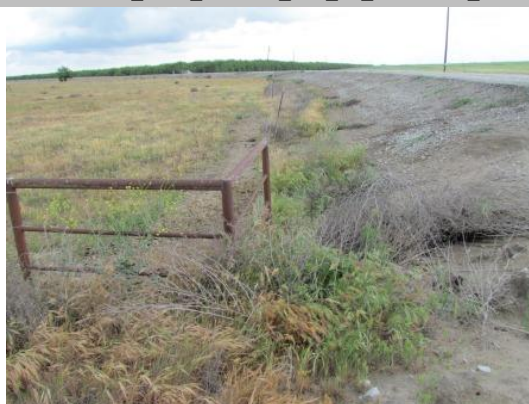
Photo 1 of 1 : SP_2018_NA0011_145_56_20180307_00015.jpg

Fence within the 10-foot of levee toe. This encroachment was recorded on 11-01-2012. Photo was taken 4-24-2014.

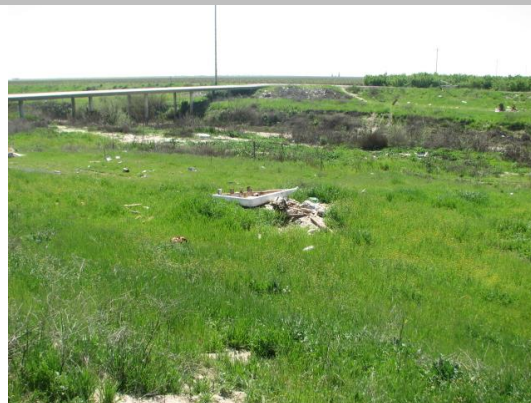
Photo 1 of 1 : SP_2018_NA0011_146_19_20180411_00021.jpg

Looking west at garage in channel. (Spring 2018)

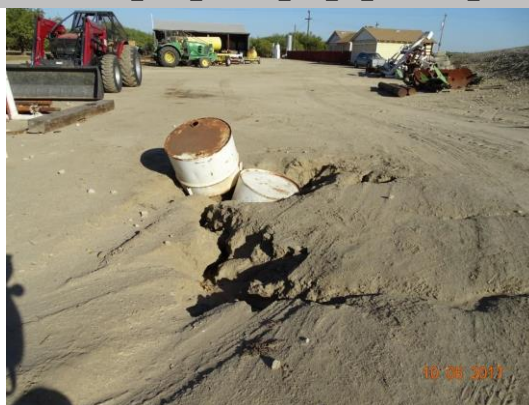
Photo 1 of 2 : SP_2018_NA0011_146_25_20180307_00007.jpg

Possible sinkhole 10 feet from landside levee toe. 6 ft long by 1-2 ft wide by 5.5 ft deep. White 55gal drum halves were placed in hole for safety.

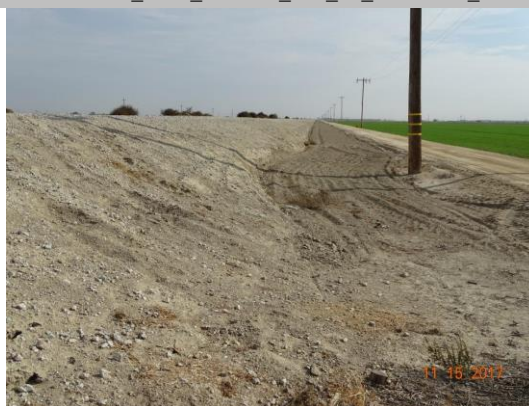
Photo 1 of 1 : SP_2018_NA0011_147_27_20180307_00009.jpg

Ag activity has cut into landside toe. Activity should be stopped and levee slope repaired.

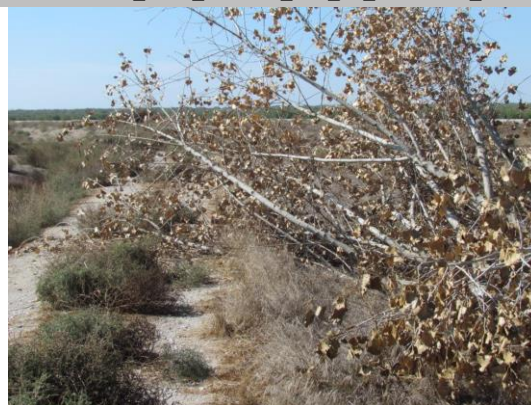
Photo 1 of 2 : SP_2018_NA0011_147_36_20180307_00014.jpg

Dead tree pushed upon the waterside slope and blocking the crown.

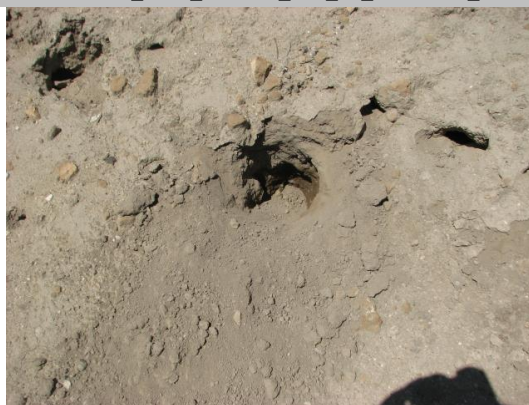
Photo 1 of 1 : SP_2018_NA0011_147_51_20180411_00045.jpg

Looking at typical rodent holes on landward slope. (Spring 2018)
